FLOODWAY
FLOOD BOUNDARY AND FLOODWAY MAP

FAIRFIELD COUNTY, OHIO
(UNINCORPORATED AREAS)

PANEL 10 OF 200
(SEE MAP INDEX FOR PANELS NOT PRINTED)

EFFECTIVE DATE:
APRIL 17, 1989

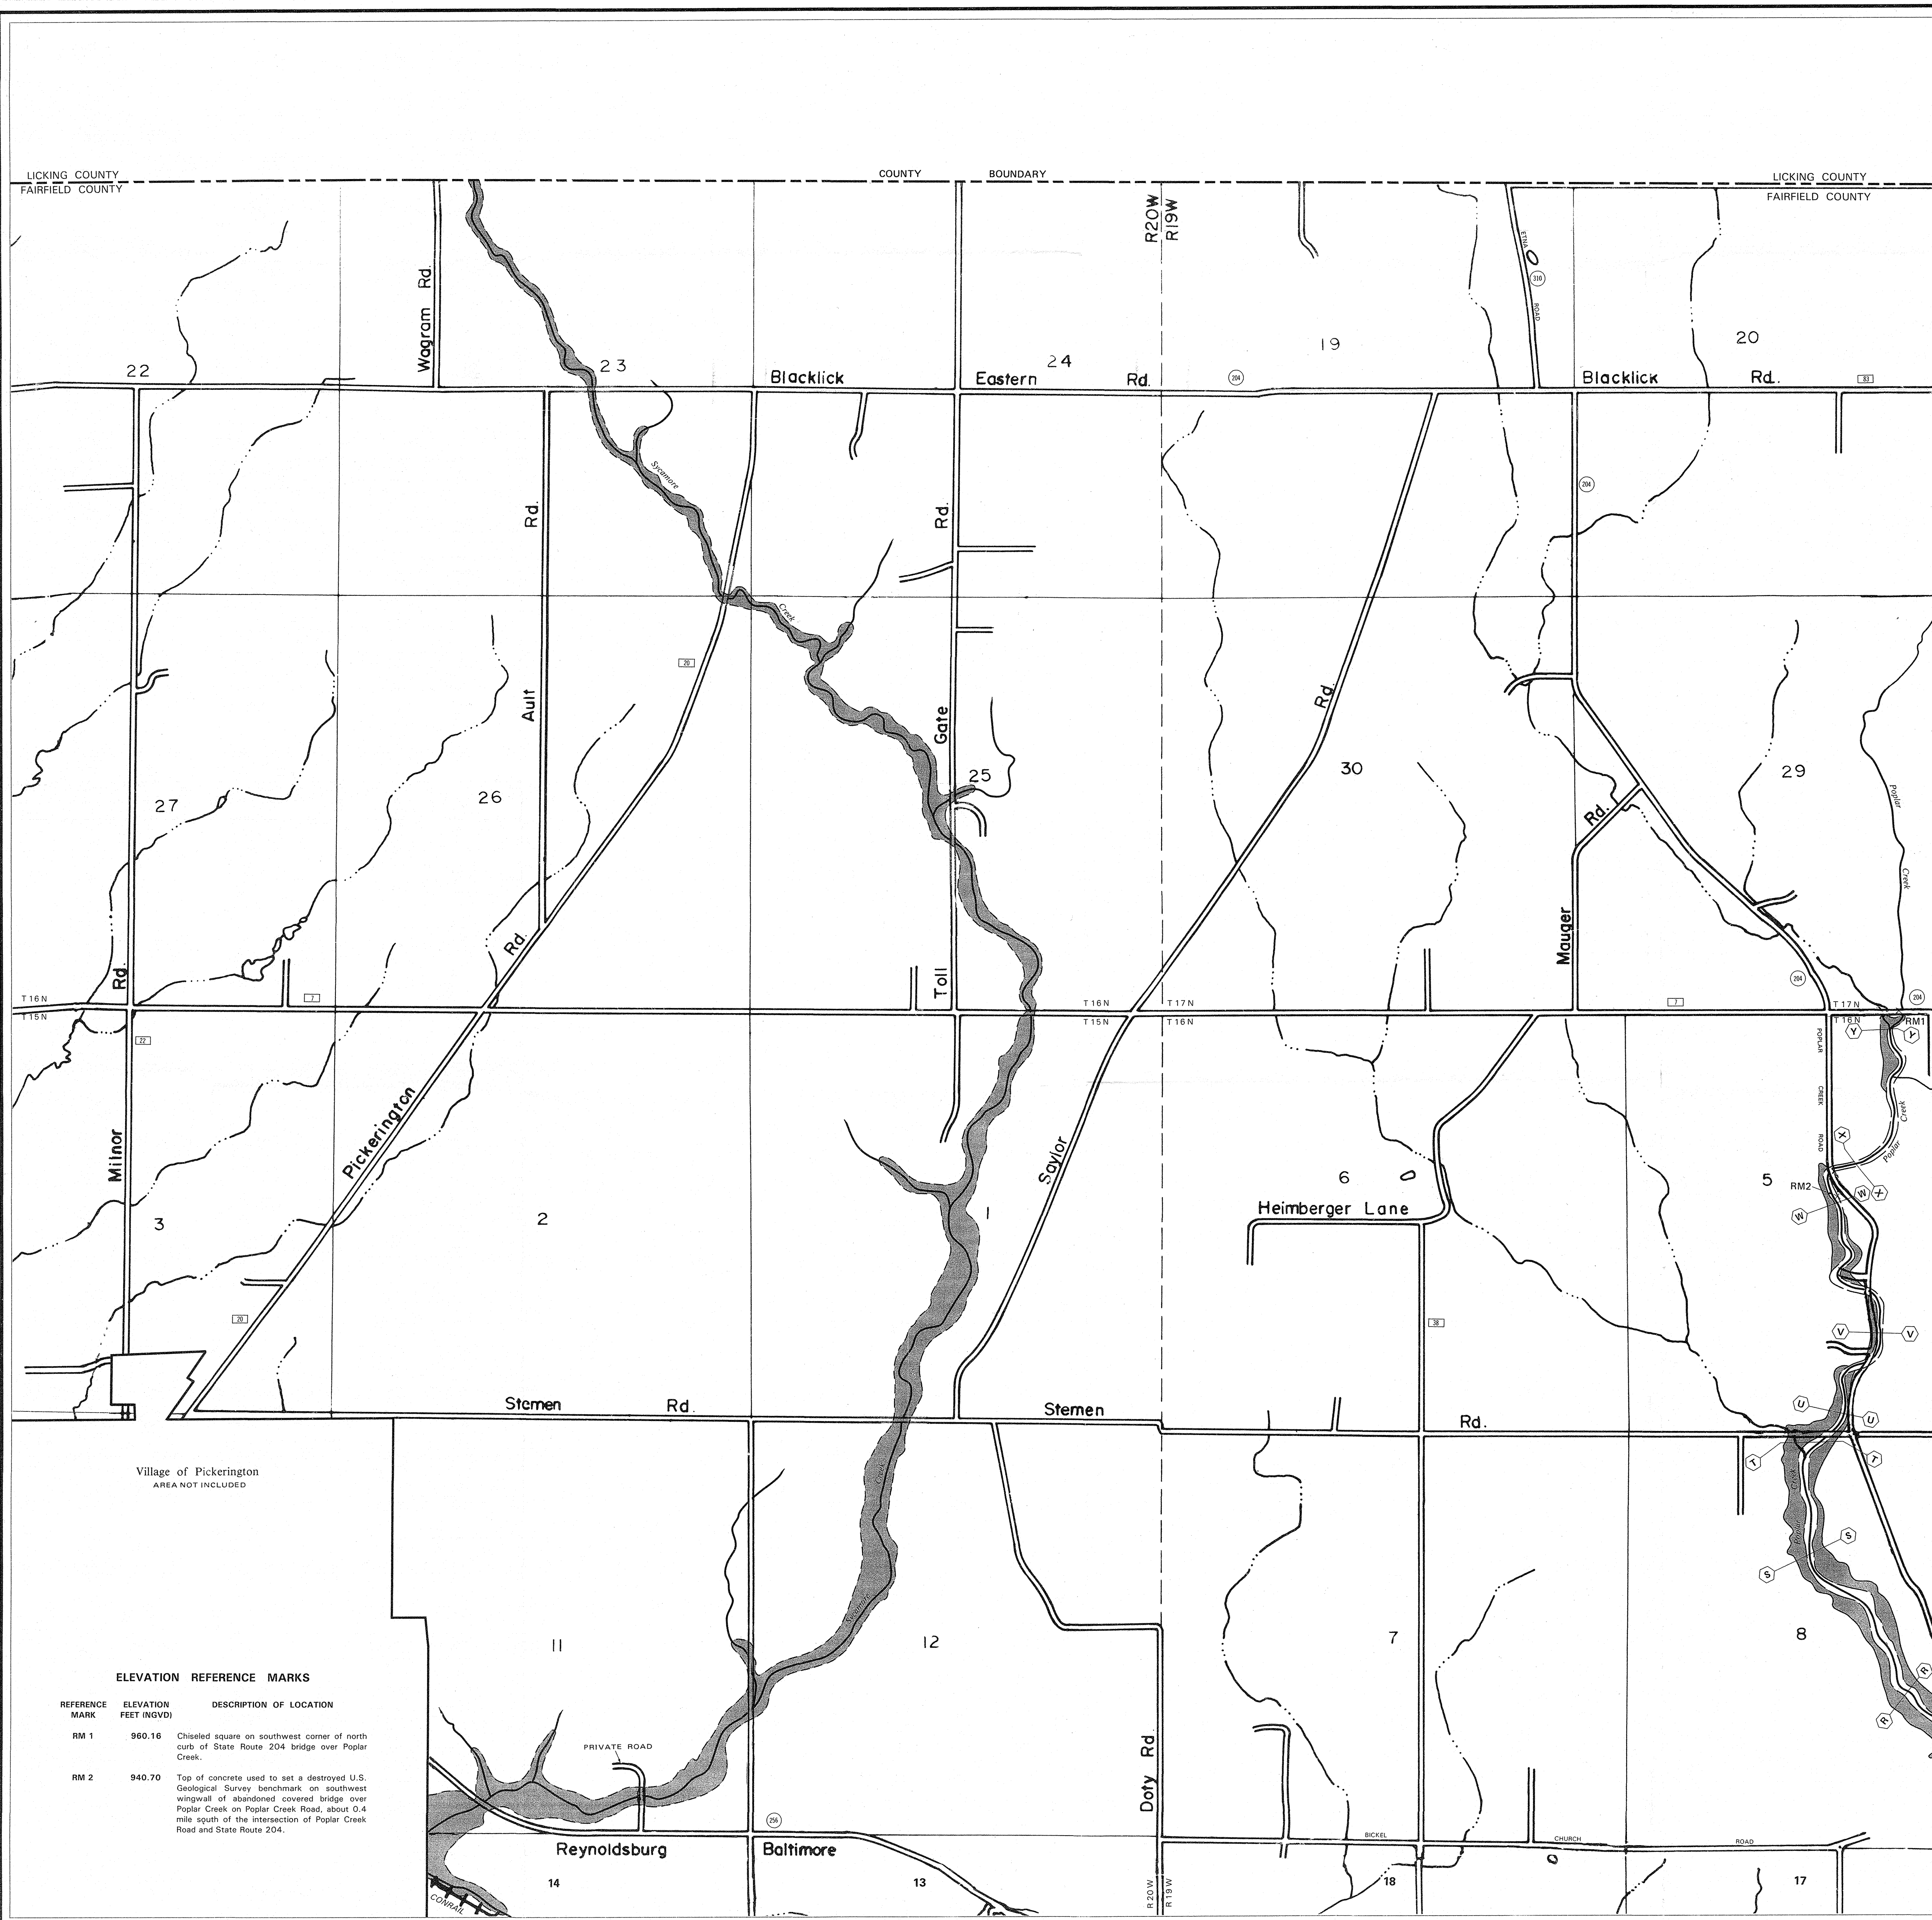
KEY TO MAP

500-Year Flood Boundary

100-Year Flood Boundary

FLOODWAY FRINGE

Approximate 100-Year Flood Boundary

Cross Section Line

Elevation Reference Mark

River Mile
